Veneer Inspection Program

This large commercial retail client recognized it had safety and cosmetic appearance issues with architectural stone veneer falling off of numerous stores across the country. The client needed data and information to determine how widespread the problem was, along with an analysis of why the failures were occurring.

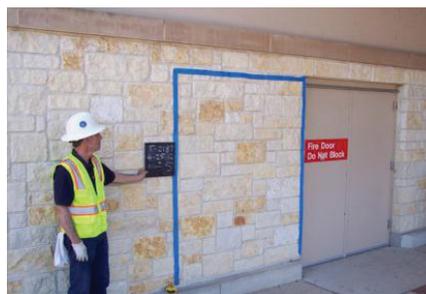
Testing and inspection

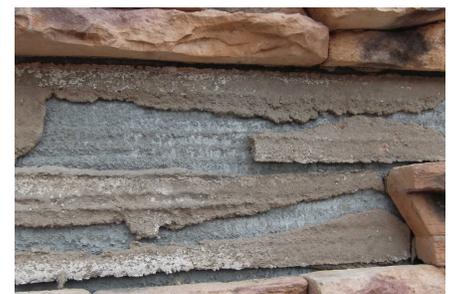
Our inspections identified that a large number of stores were experiencing veneer failures, with approximately 10 percent creating potentially serious safety concerns. We determined these failures resulted from inadequate installation, and we helped develop improvements in our client's building specifications to correct the problems. All of this led to the development of a better-defined testing and inspection protocol—and ultimately a reduction in safety risk to its customers nationwide.

Failed veneer unit
